# Access on Annual Inspection

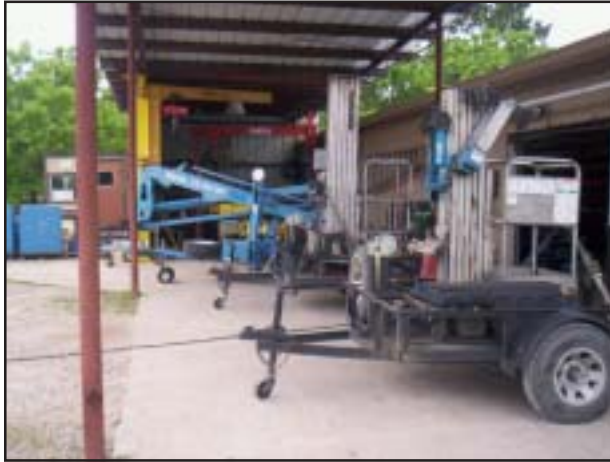
It is difficult to understand how some crane inspection company's perform an OSHA inspection without accessing the underside of the bridge crane or hoist. This is one of the most overlooked areas. We have seen many failures over the years that may have been prevented if only the inspector took the time and came prepared with the necessary equipment to inspect the underside of the equipment. The upper tackle on the hoist is the most critical. This is where you find the running sheaves, equalizer sheaves, pins and bearings. The most critical area is the center of the load cable that sets over the equalizer sheave. On a true vertical

lift hoist the area of the cable that sits over the equalizer sheave can be subject to more wear. The cable is constantly rocking back and forth over a very small area. This rocking motion over time can cause the load cable itself to break down. We have inspected many load cables that appear fine, until we inspected the area over the equalizer sheave and found it to be in such bad shape that the crane needed to be shut down until repairs could be made.

**AOC** comes prepared. Our equipment consists of a bucket truck and a number of man lifts ranging from 30 ft to 42 ft working heights. The next time you have your cranes inspected; ask the inspector "how they plan on accessing the underside of the equipment?"
